Applying Ostomy Care Concepts to Practice

R. B. Turnbull Jr. MD WOC Nursing Education Program

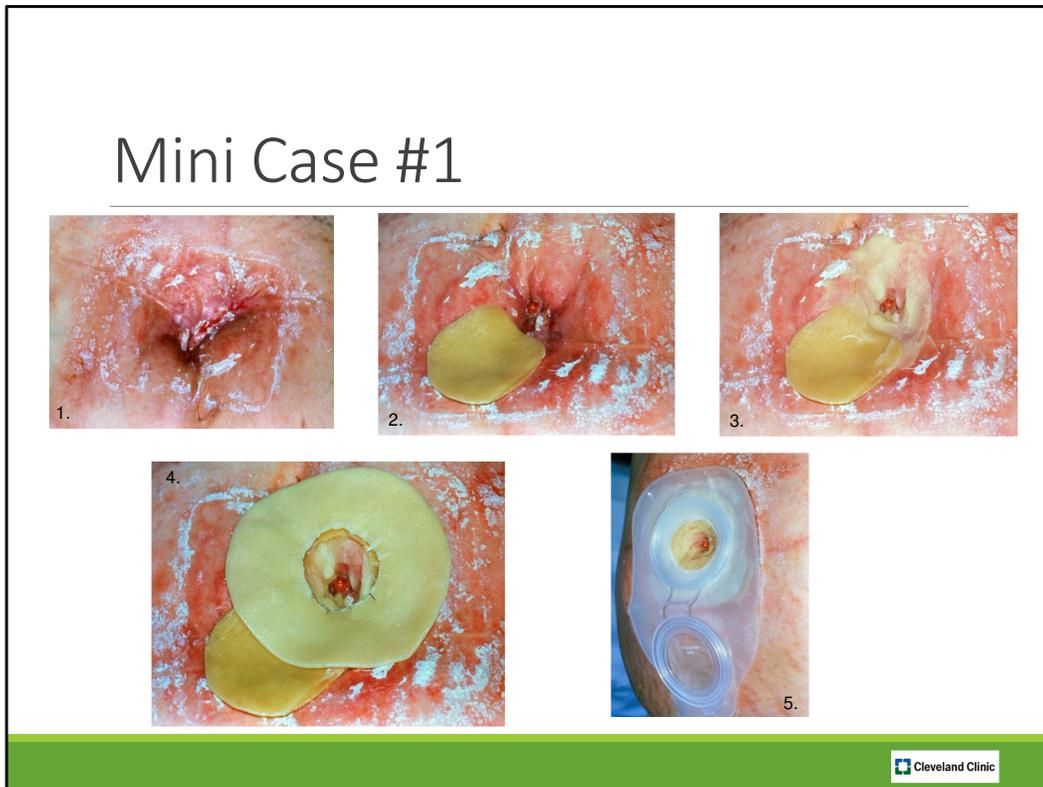
Mini Case #1

The fistula in this example is located at the bottom of this dimpled area. The white color is residual skin cement, which does not need to be removed in its entirety; it will come off with the next change. The dip area around this fistula is filled in with a skin barrier wedge, as is seen in picture two. A small caulking with skin barrier paste is followed by the use of a skin barrier washer, as seen in picture 4. Note the radial slits around the aperture; this allows the barrier to move a bit with changes in body contour which will keep the washer from lifting from the skin. One can see the pouch in place in picture 5; the aperture of the pouch is larger than the aperture of the washer, giving a tiered or layered effect. This helps to prevent the effluent from coming between the layers and undermining the pouch seal. In this instance, the WOC nurse went back in through the window of the pouch and applied skin barrier paste, with a light dusting of skin barrier powder, over the exposed skin to provide it with protection against the fistula output. One could also picture -frame the edges of the pouching system of added support.

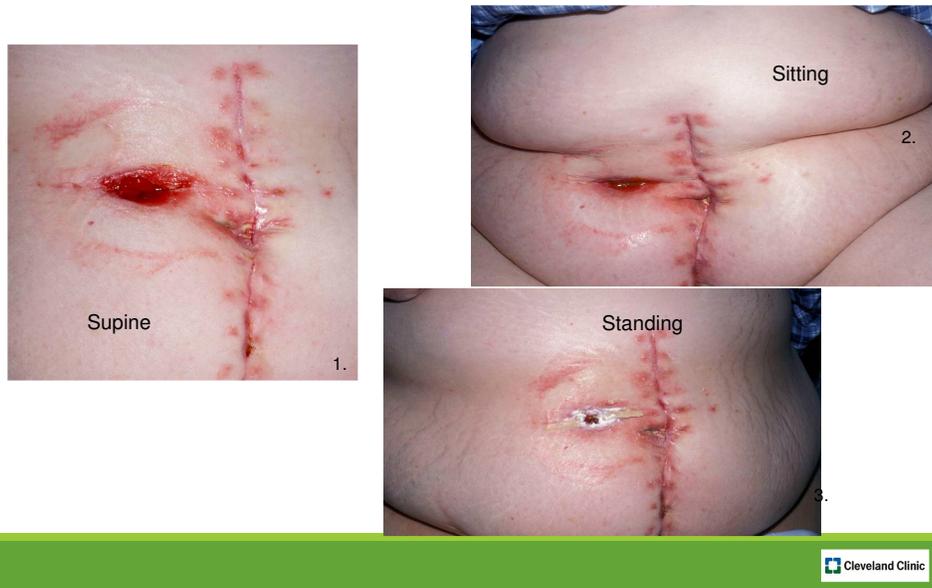
Mini Case Study #2

This woman has a loop ileostomy located above the umbilicus, near a body crease, with a very firm abdomen, and a retracted stoma. In viewing picture one on the left, an individual can easily see the degree of chemical irritant dermatitis that has occurred secondary to pouching difficulties. A variety of pouching systems were used before the illustrated system was found. She did require a bit of support around the peristomal area, but all integrated convexities, even the softest, buckled and leaked. In picture 2, one can see there are two depressions at 3 and 9 o'clock, and the stoma retracts further with sitting than when flat. The skin was dusted with skin barrier powder to dry the denuded tissue to improve adhesion of the adhesives in the pouching system. The dips at 3 and 9 o'clock were filled with thin wedges of solid skin barrier to begin to make a flat pouching surface. Note that the wedges are placed a little distance away from the stoma; this is to fill in yet not have undermining of the wedges.

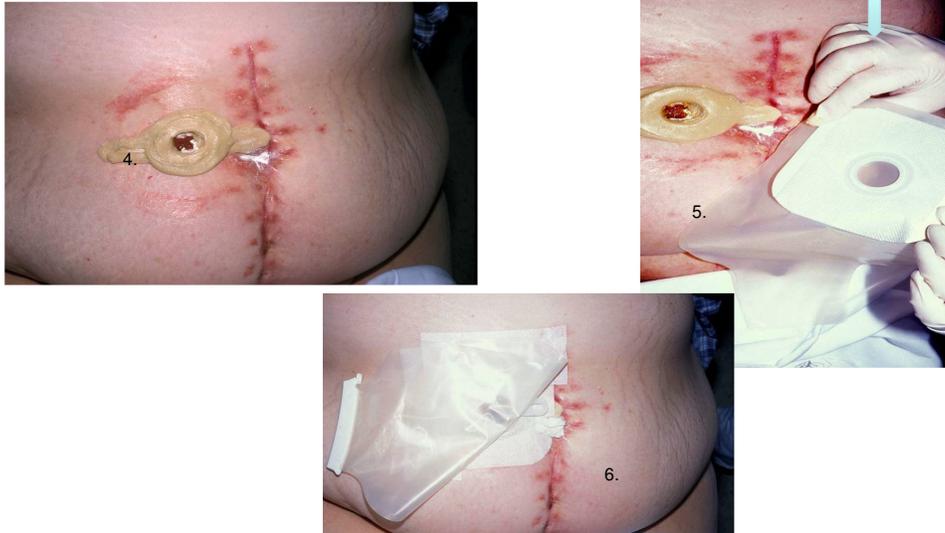
Mini Case Study #2: Continued

In image 4, one can see a skin barrier washer was added for protection of the peristomal skin; the aperture was cut wider than the stoma size. The edges of the barrier wedges were caulked with skin barrier paste. A Hollister premium pouch had the karaya ring removed, which provides a flat pouching system that gives mild support to the tissues of the peristomal plane. Note the arrow in picture 5; usually when the washer is removed, the back of the junction of the tape collar and plastic ring receives a light caulk with skin barrier paste. This prevents the effluent from leaching under the tape collar. In picture 6, one can see the edge of the skin barrier wedge protruding from beneath the pouching system. This will be covered when the edges of the tape collar are picture-framed with added tape, half on the collar of the pouching system and half on the surrounding skin. A belt was also applied for added stability and support. A three-day wear time was obtained using this system.

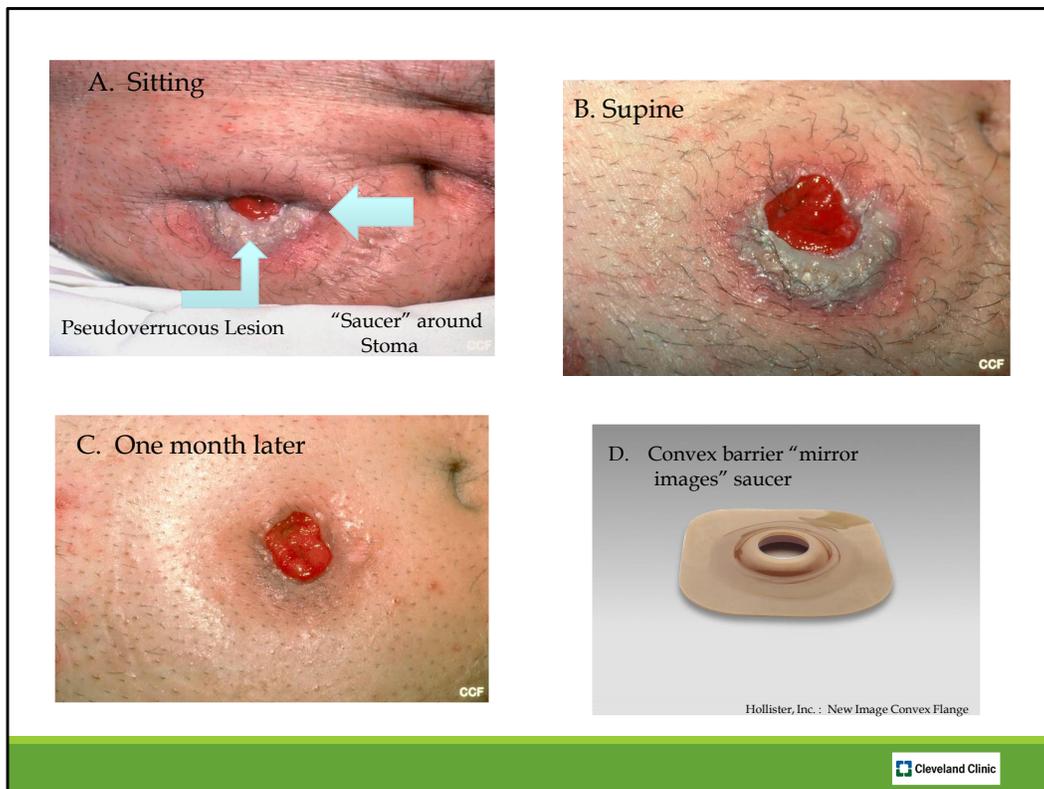
Chemical irritant dermatitis also occurs with urinary stomas. Because urine has no enzymatic component, one does not see denuded tissue. The skin absorbs fluid and becomes hydrated leading to pseudoverrucous lesions. In layman's terms it is known as dishpan hands of the peristomal skin, a condition similar to what hands look like when exposed to water for an extended period. The skin becomes wart-like in appearance, soft, spongy, gray-white in color, and can be painful. Treatment is the same as noted for chemical irritant dermatitis with fecal stomas without the use of powder. Recommended for use with urinary stomas are pouching systems with extended wear barrier. These barriers swell when in contact with fluids so provide increased protection to the peristomal skin. The pictures in this slide show an individual with pseudoverrucous lesions around his stoma. Note the contour changes in the sitting and supine positions. Use of a pre-cut convex pouching system provided the appropriate match for this individual's contours. With urine no longer bathing the peristomal skin, the epidermis went on to heal within one month.

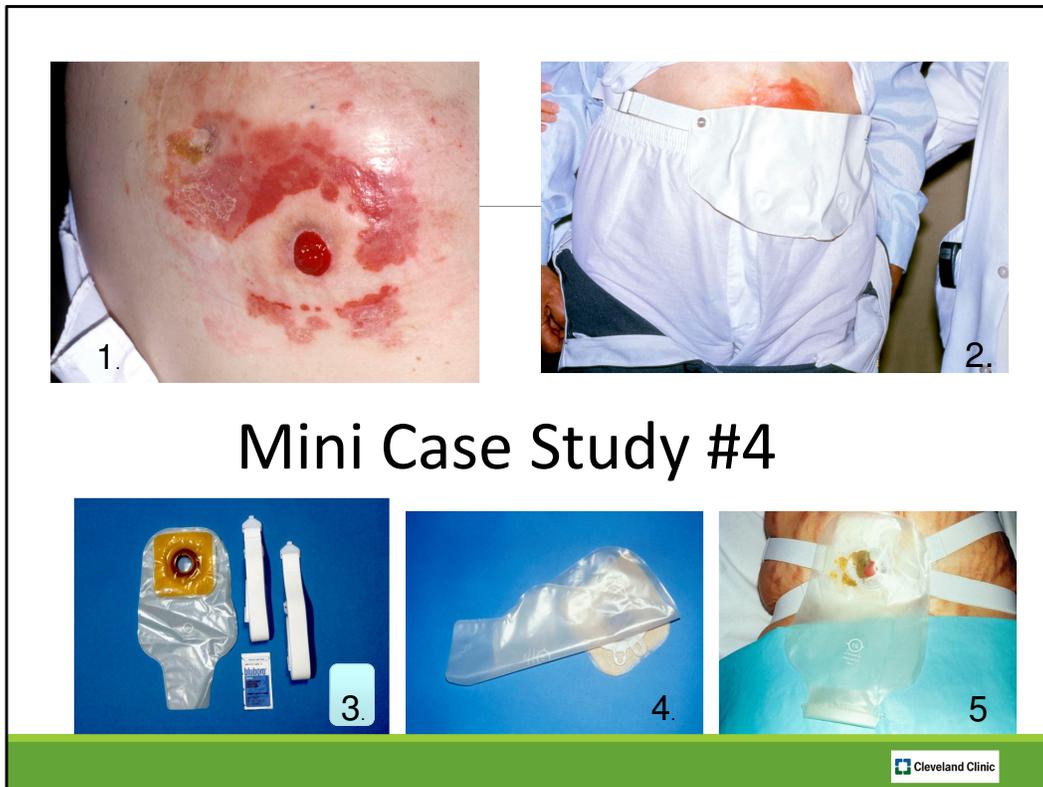
Mini Case Study #4

This individual has severe psoriasis around his urinary stoma which was placed on the left side secondary to radiation changes internally. One can see the silvery raised tissue. The area near the umbilicus is also affected; it is a light yellow-brown color. This is a result of fluid seepage, which dried and discolored the plaque. His dermatologist prescribed a variety of medications, which were in ointment form and required application three times a day. An adherent system would not have worked, so a non-adherent system was used. Nu-Hope company now has a non-adherent pouching system that can be ordered for this type of situation, making pouching less labor intensive and product consuming. The non-adherent system is in place; the pouch was placed over this gentleman's underwear to keep the pouch plastic off of the skin. However, one can make a non-adherent system while waiting for an ordered non-adherent system to arrive, or as a non-adherent alternate choice.

In picture three, the component parts are shown: a pouching system (any system can be made non-adherent); a skin barrier that is non-sticky on one side; it needs to be entirely smooth and non-adherent; and two belts. Not pictured are the belt rings needed. This photo shows Hollister belt rings in use, but one can cannibalize any pouching system that uses a belt to claim a "belt ring". The stoma aperture is cut to the appropriate size in the skin barrier. The release papers are removed and the adherent side of the barrier is attached to the adherent side of the pouching system. After the pouches release papers are removed, of course. This makes the system non-adherent. The end product is seen in picture four. The belt rings are then placed over the pouch and rest above the skin barrier, as viewed in picture five. Ideally, the belt tabs are located at the 2, 4, 8, and 10 o'clock positions. As one can see in picture five, two belts are then secured to the pouching system:

one from 2 and 10 o'clock, the second from 4 and 8 o'clock. The belts are applied a bit more tightly than usual as they are the only things holding the pouching system in place. Care must be taken not to make them too tight in order to prevent pressure or laceration injuries from the belts. Taping of the belts in position can help to keep the belts in place and prevent shifting of the system.

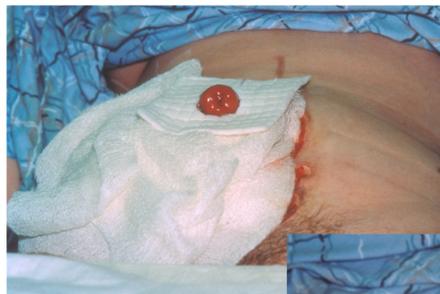
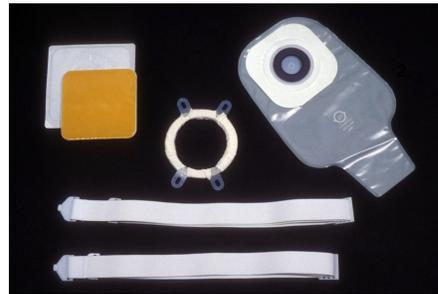
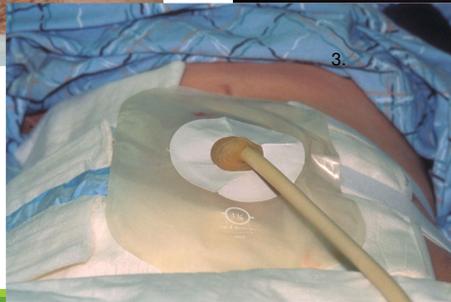
Mini Case Study #5: One Solution

The wound was covered with normal saline moistened gauze and a layer of dry gauze was placed immediately around the stoma. A non-adherent pouching system was assembled and placed around the stoma. She was taken to the operating room for serial debridement until the wound was clean. The physicians requested an indwelling catheter, inflated with five milliliters of fluid, was placed into the stoma and held in position with a catheter holder. This system throughout her hospital stay, which included coverage of the defect after a week with a split thickness skin graft. She was sent to an extended care facility upon discharge from the acute care hospital using the non-adherent system over the graft, the indwelling catheter, and antibiotic therapy.

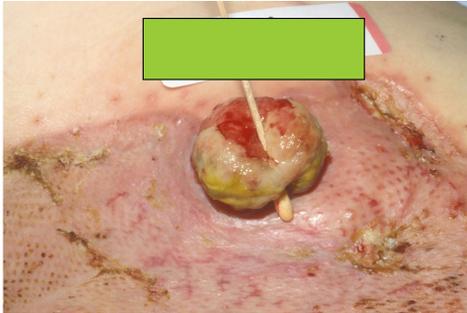
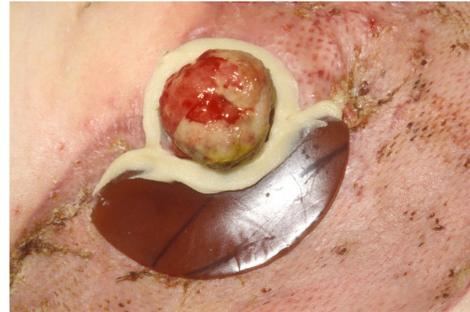
Mini Case Study #5: The Saga Continues . . .

She returned on the weekend less than a week after discharge secondary to inability to maintain a pouch seal. Upon inspection, superficial slough was noted over the majority of the stoma along with a fistula seen at the base of the stoma. There was a dip along the edges of the graft, making about a quarter of inch drop. This area was filled in with a karaya washer, which is non-adherent so would not hurt the fresh graft, then the area was lightly caulked with a skin barrier paste. Adaptic, a gauze dressing that is impregnated with Aquafor ointment, was applied over the graft next to the karaya washer. A dry dressing was placed on top of the adaptic, and a soft, flexible adherent pouching system was applied over the barrier. All edges of the pouching system were taped in place. The patient had a local stoma revision and the same system was used until the plastic's service gave the go-ahead to use an adhesive system over the grafted area.

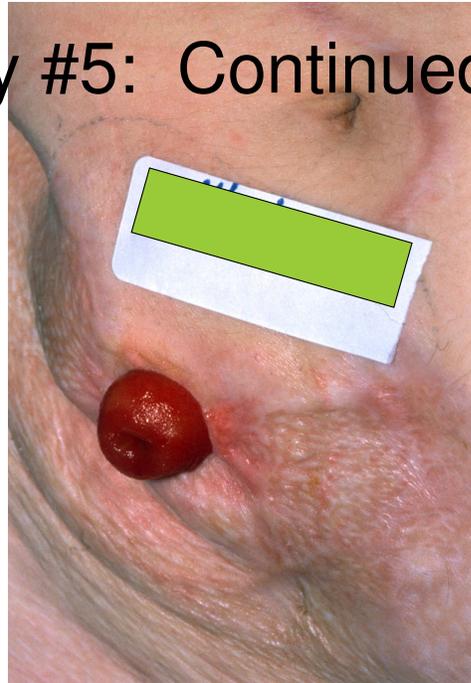
Mini Case Study #5: Continued

One can see the excellent healing that occurred. The patient is now using a one-piece, pre-cut, opaque pouching system with skin barrier ring without any difficulty. The occasional skin irritation is treated with skin barrier powder.
